In limited circumstances the BBLDWP may be able to issue a toilet replacement rebate without a pre-inspection. To do so, we need as much documentation and evidence as we can get to verify that the existing/pre-existing toilet is a high flow toilet and therefore qualifies for our rebate program. Specifically we need photos of the toilet, including any of the following markings: make, model, flow rate, year or date of manufacture, and size of the tank. The following are examples of what does and does not work in terms of photos. We need a minimum of two photos - one showing the entire toilet from the front and at least one that shows us a date of manufacture and/or the make and model of the toilet. If you cannot find a date, we need photos of all measurements. Providing photos does not guarantee eligibility.

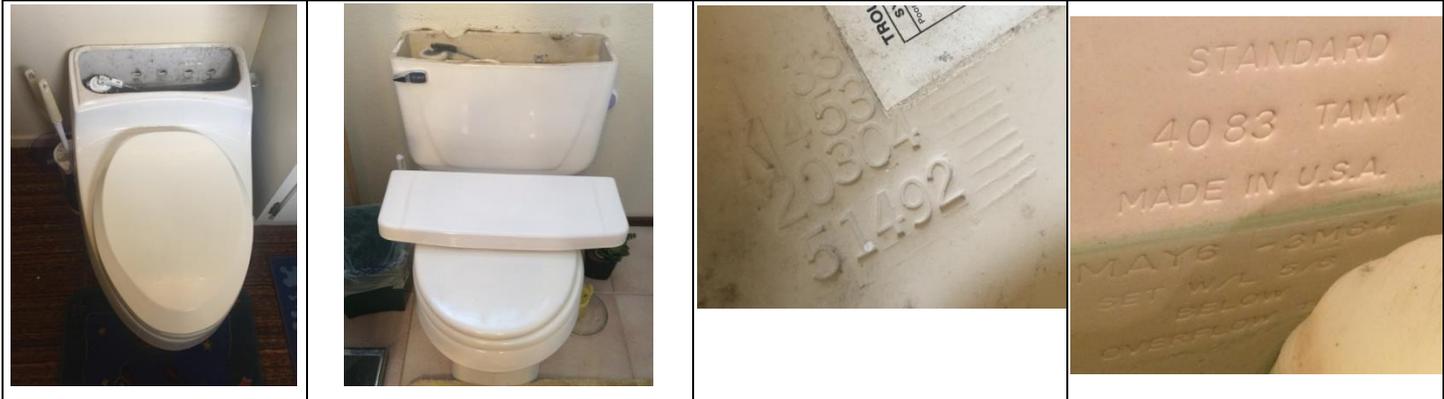
GOOD PHOTOS

(ABOVE) Good photos, but we would need more to prove these are high flow toilets. They are helpful in that we can see a portion of the bathroom where they are and get a sense of scale and shape which helps us to identify them.

This photo shows the model and the date of production (51492 likely means it was manufactured May 14, 1992). K453 is a Kohler model.

This photo shows the make: Standard, the tank model: 4083, and the date of manufacture May 6 – “3M64” likely means it was manufactured in 1964.

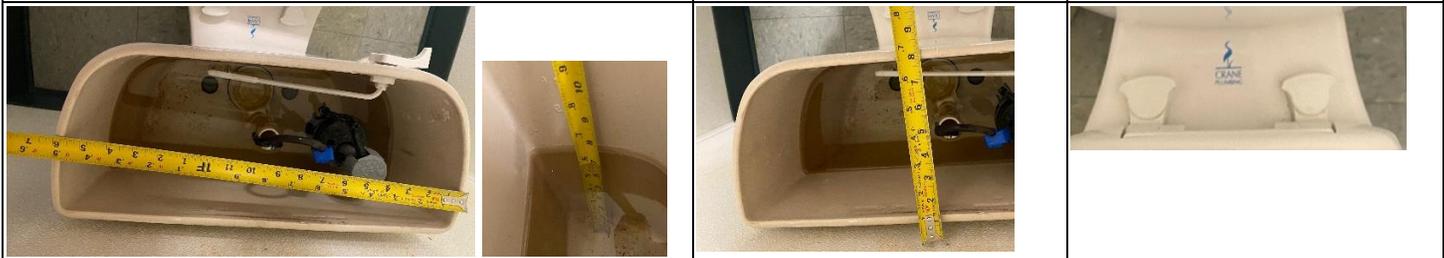
These are helpful to show the tank width, front to back “depth” and water level depth. The logo is also often helpful because some logos are indicative of a date of manufacture. *Photos are a sample only. This tank is actually 1.6 gpf

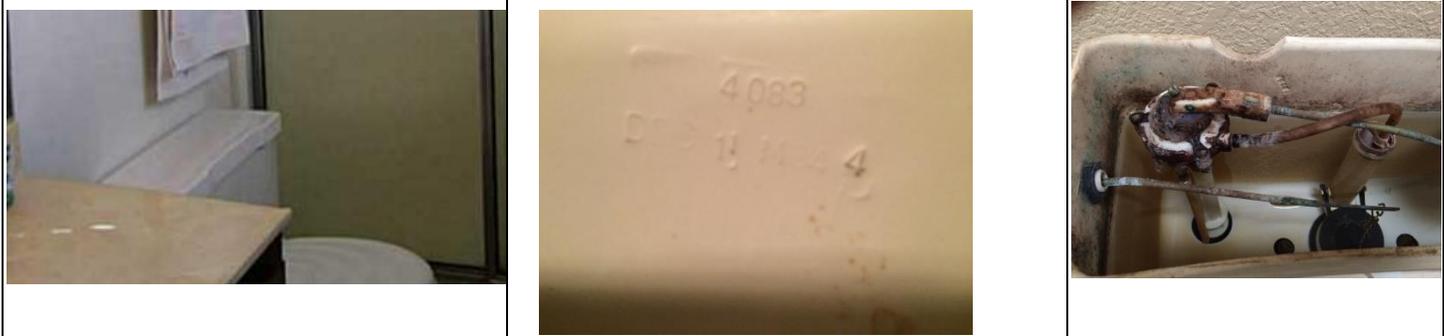
BAD PHOTOS

We cannot tell anything from this photo.

This photo might be showing a model but it is too blurry and limited for us to tell anything else.

This might help in conjunction with other photos, but we cannot gather any vital data from this photo.
